Roof Condition Report

9BDS - Thaw Shed

Intermountain Power Service Corporation
850 West Brush Wellman Road
Delta, Utah

June 2001

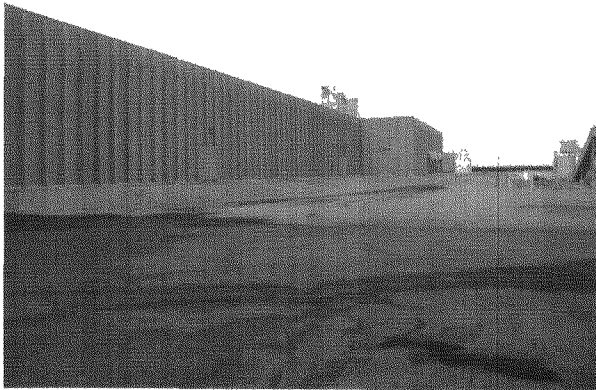
Photo No. 1

The north side of the building, looking west.

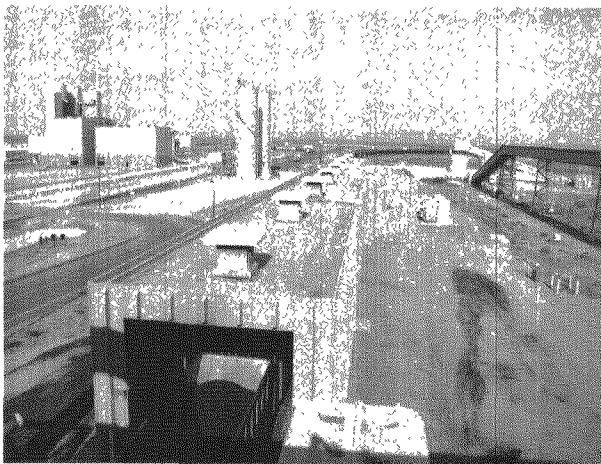
Photo No. 2

The roof of the building, looking west. The roof was too high for access using our ladder so the building will be evaluated later.

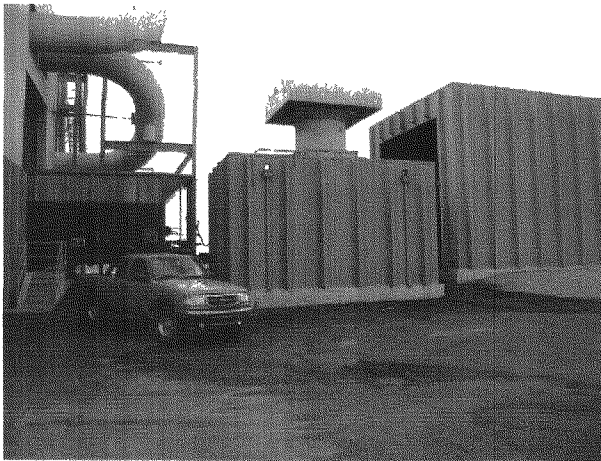
Photo No. 3

A small building between the Thaw Shed and the Coal Car Unloading building.
